APOLLO RCS POSITIVE EXPULSION TANKAGE
PRODUCT IMPROVEMENT PROGRAM
FINAL REPORT - TASK E

SOLUTION OF COMMAND MODULE
AND SERVICE MODULE
BLADDER REPOSITIONING PROBLEMS

Bell Report No. 8514-928006
19 March 1970

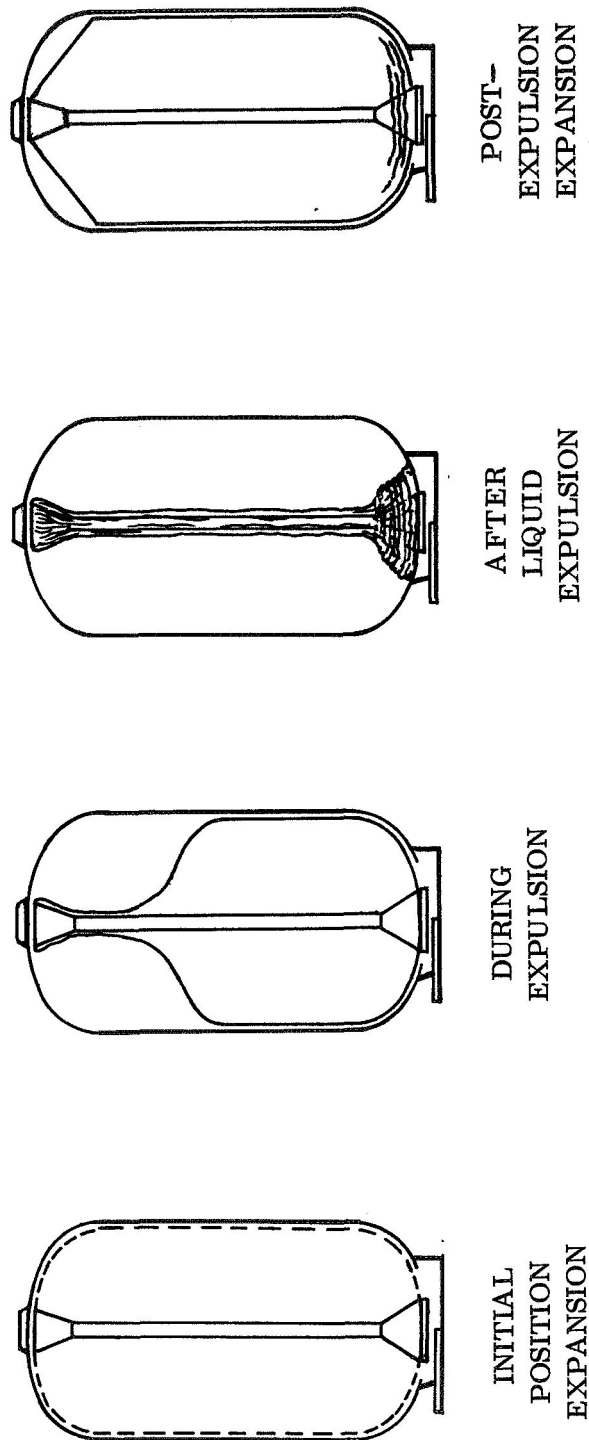
FIGURE 1. SEQUENCE OF TENSION DEVELOPMENT IN BLADDER

It has been determined by observation of previous twist tests in plexiglass tanks that twist forces buckle the hemispheres of the bladder and produce a pattern of folds which become tighter as the bladder is pressurized. Since the folds take up bladder material, the hemispherical bladder sections are initially reduced in volume. This creates a gap between the bladder and tank wall which is bridged by deformation of the bladder material

when internal pressure is applied. The folds are in diagonal tension and the bladder material between the folds is subjected to biaxial tension stresses and is thereby strained to increase the bladder volume to comply with the internal volume of the shell. After subsequent expulsion and fill operations, new folds develop, depending upon twist angle, and sequences of tight creasing and biaxial tension tend to occur in many parts of the bladder hemispherical surfaces. This sequence of loads is damaging.

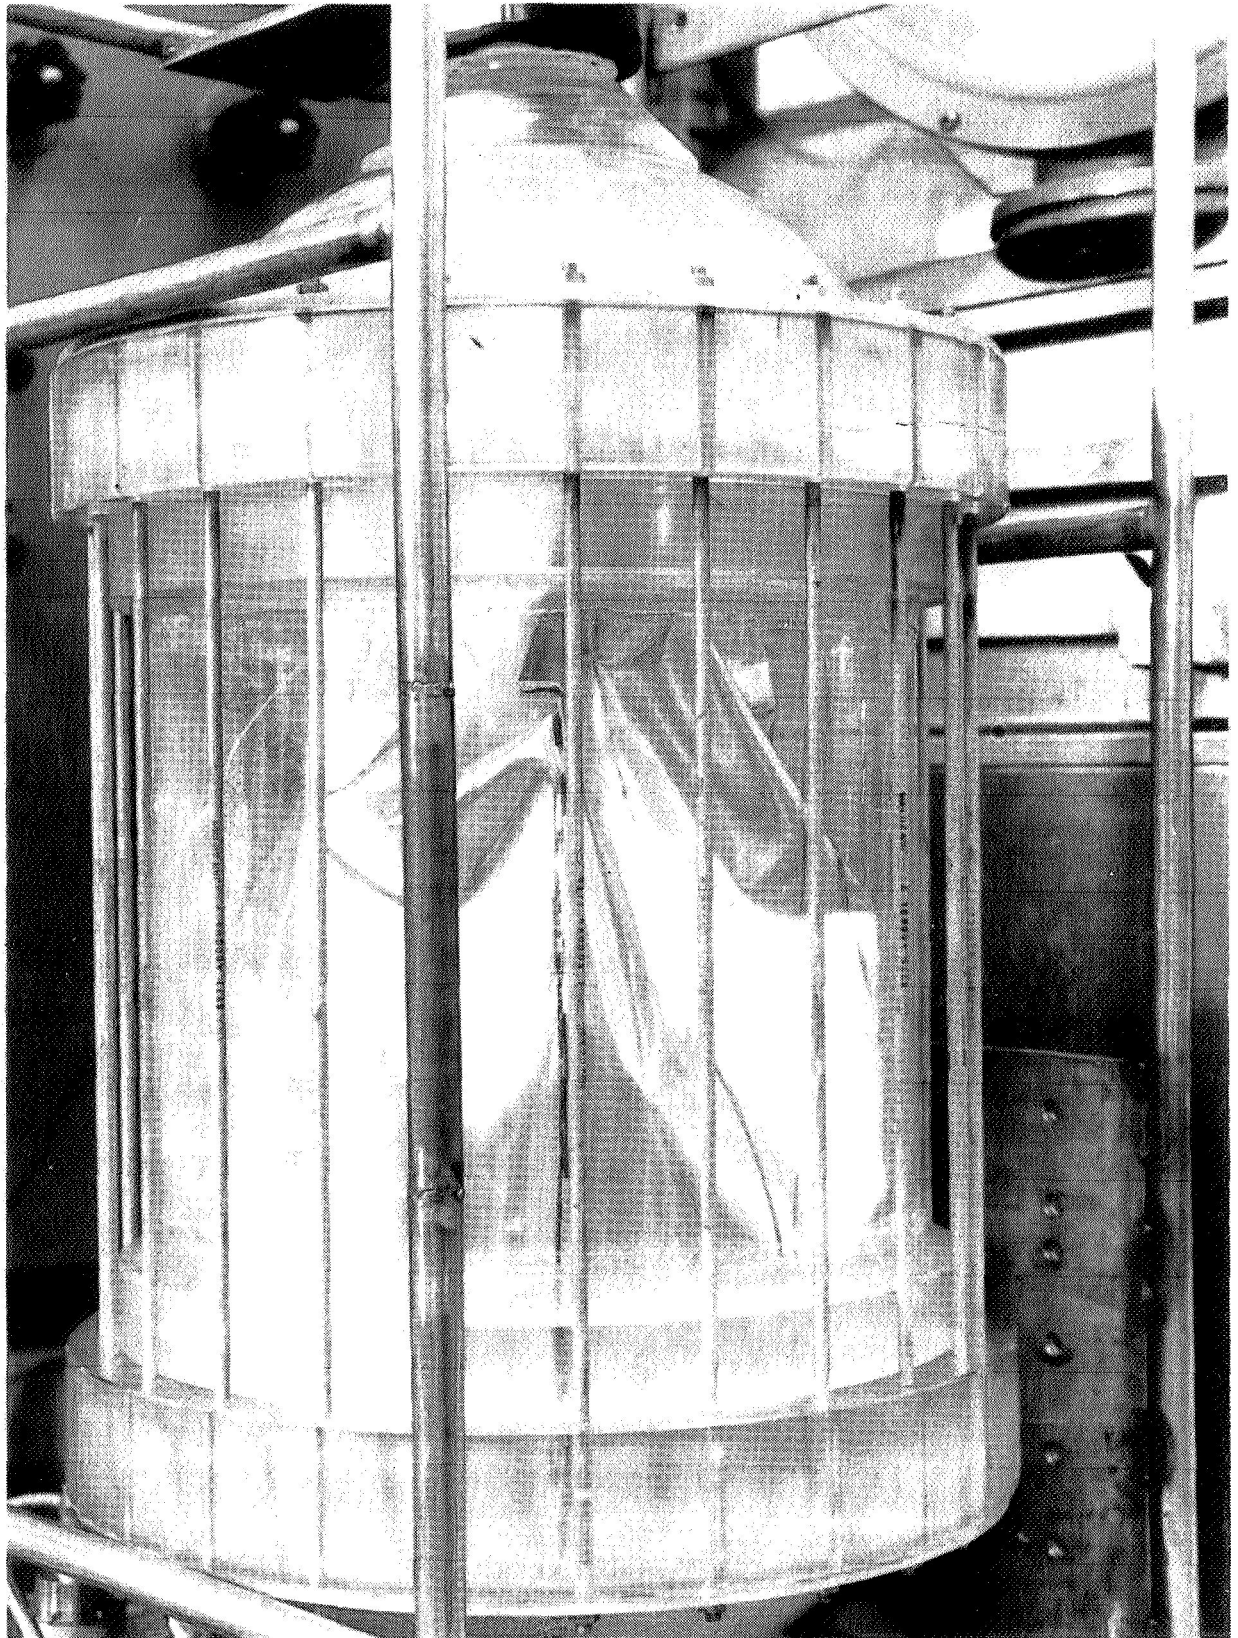
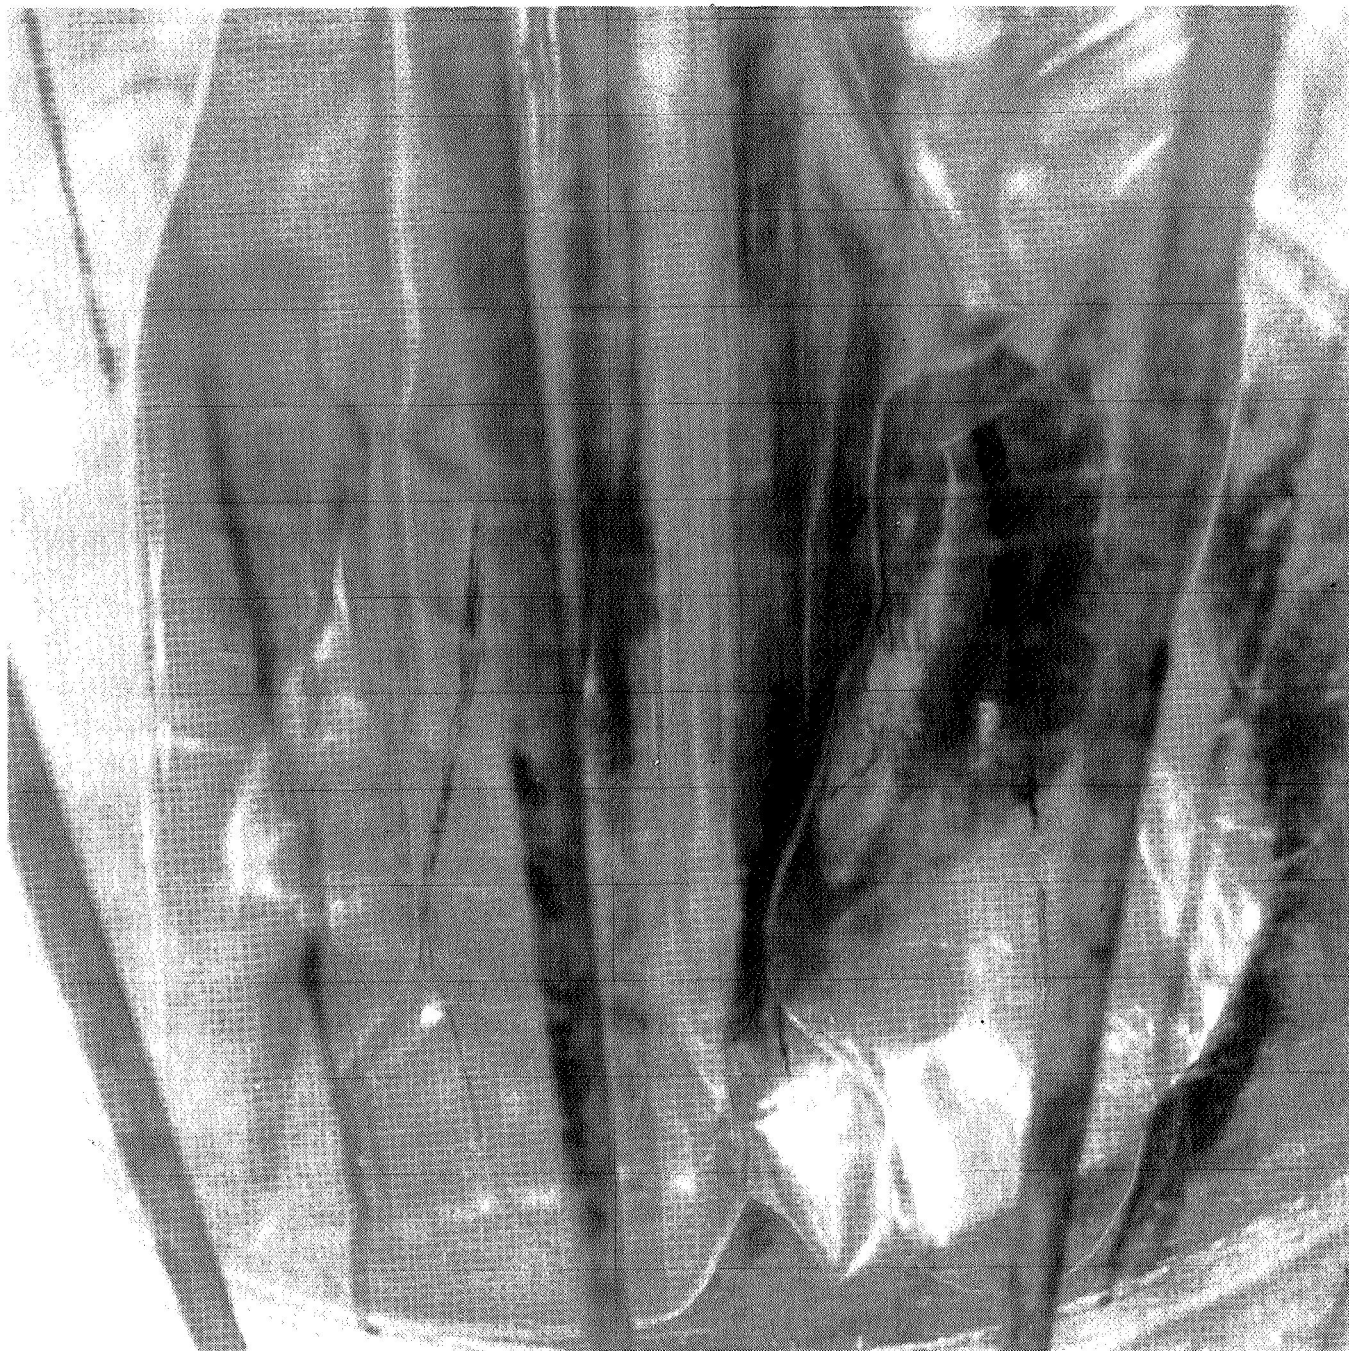
FIGURE 8. TEFLON/FOIL LAMINATE BLADDER - VERTICAL
EXPULSION - 50% EXPELLED

As expected, the bladder repositioned itself completely within the tank when re-expanded after each vertical expulsion with no visible evidence of strain. The cylindrical section of the bladder did not touch the tank wall until complete vertical positioning had occurred. Figure 8 shows the bladder half-way through the first expulsion and Figures 9 and 10 show the bladder appearance after completion of expulsion. As shown in Table 1 and Figure 11, expulsion efficiencies exceeded 99% at a tank assembly ΔP of 6 psi.

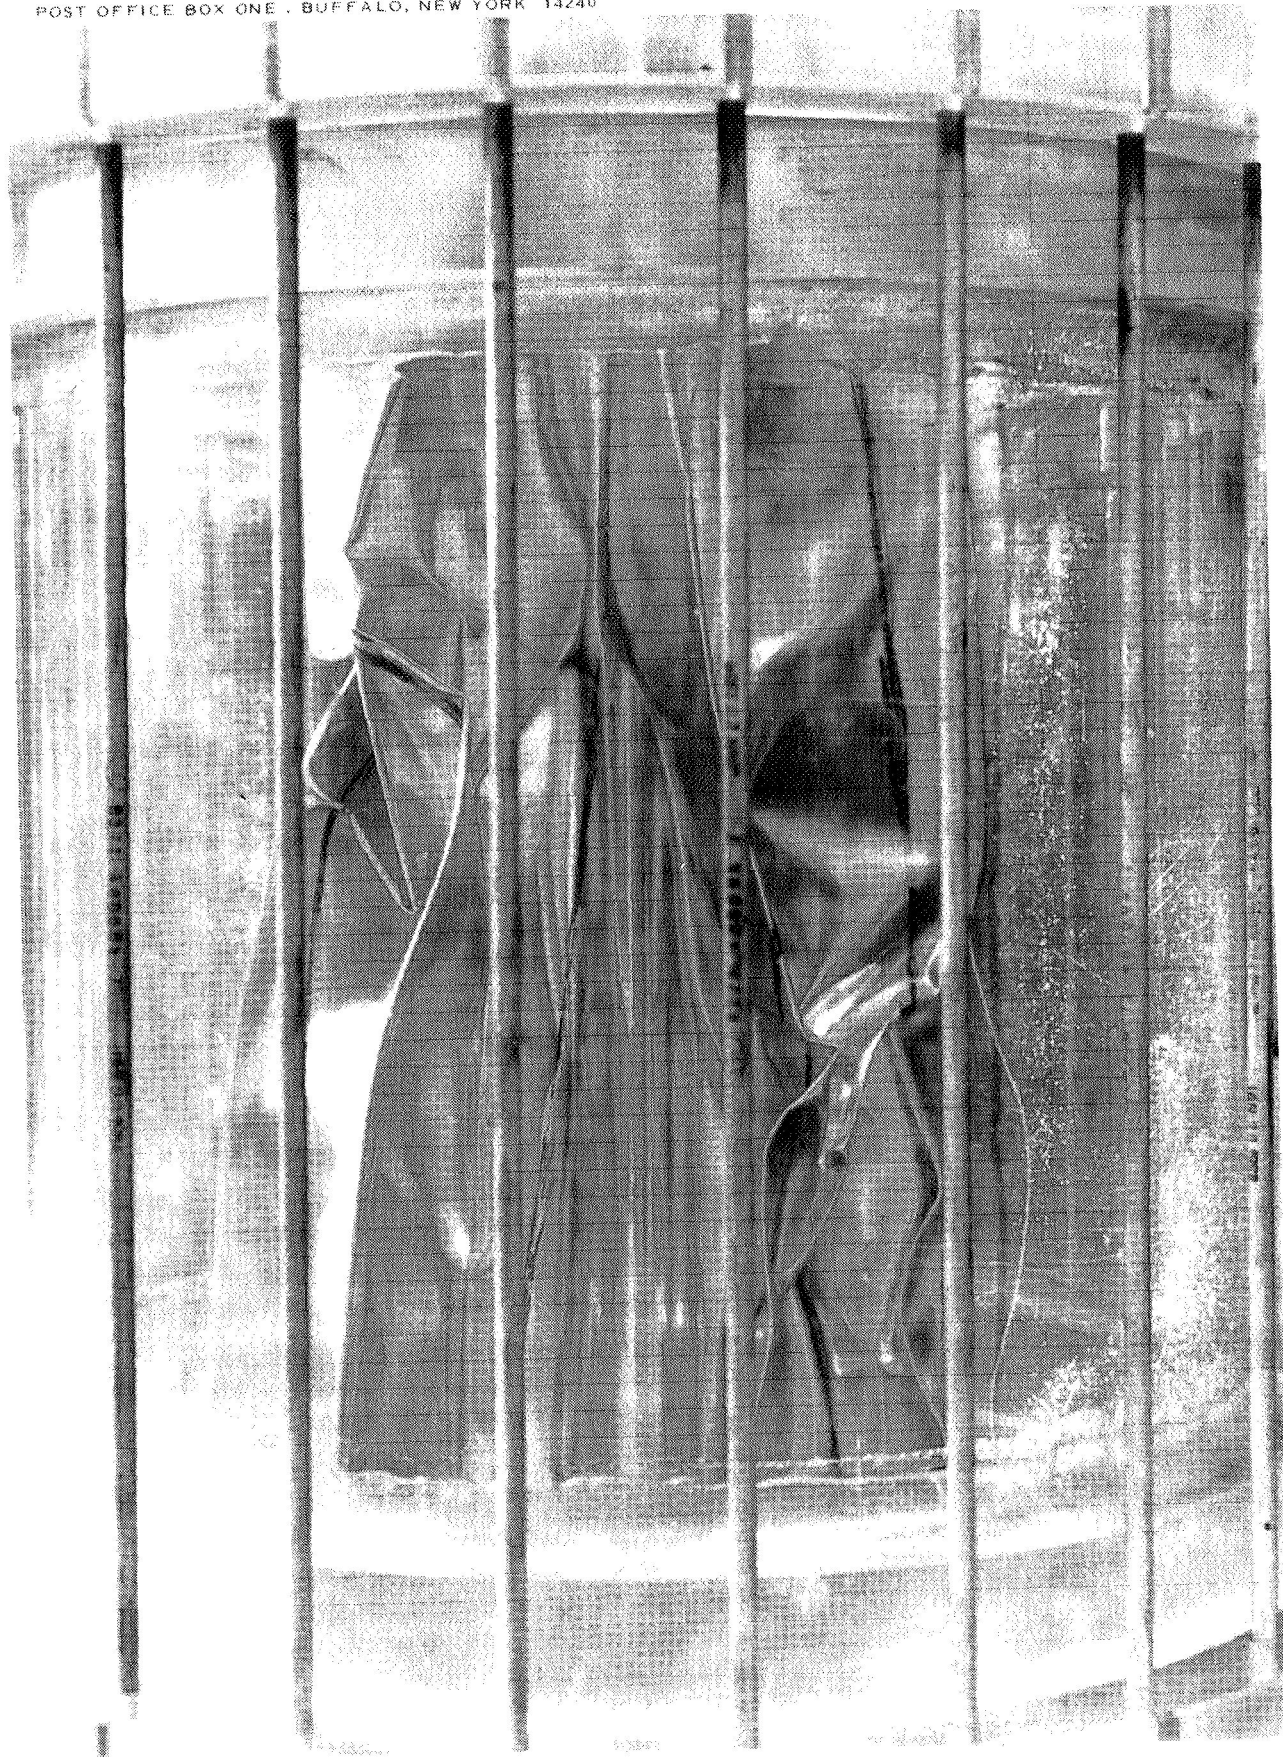
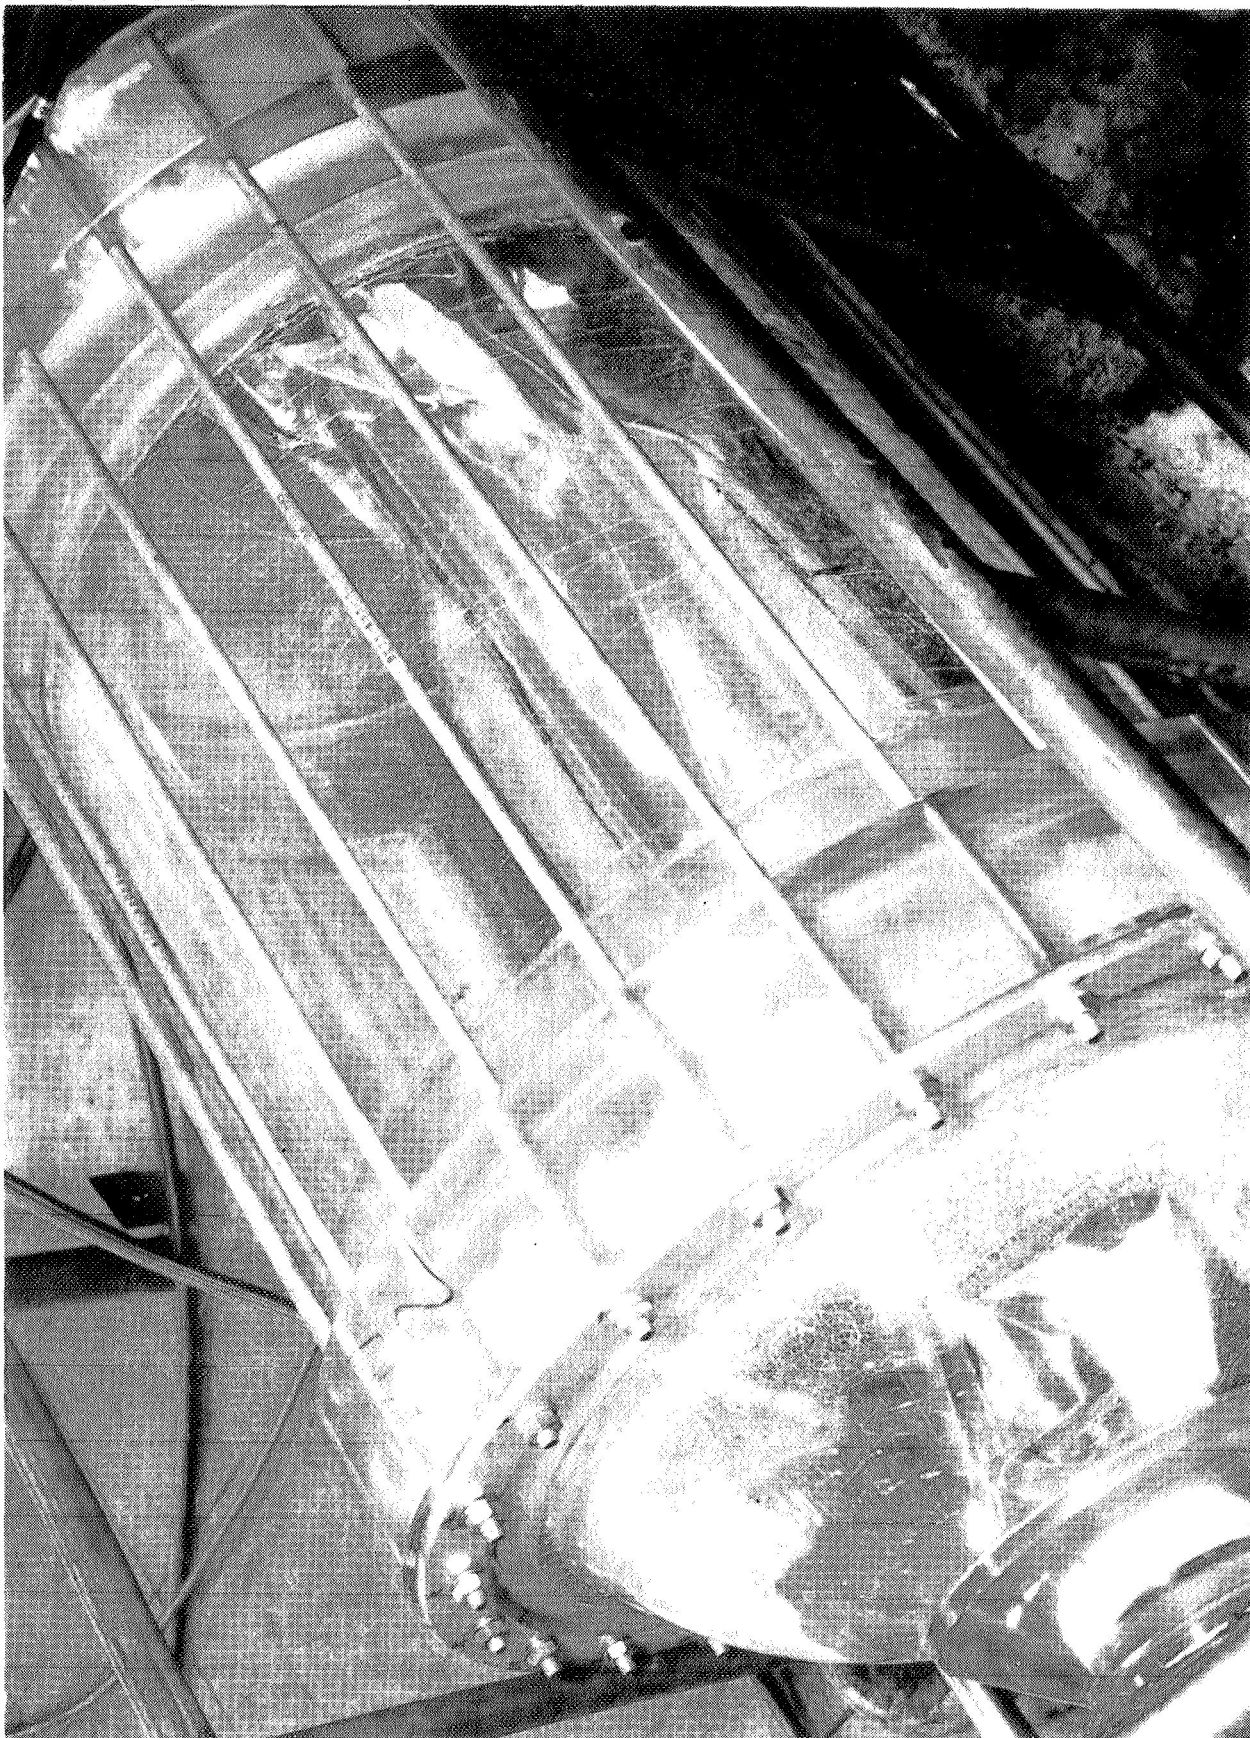
FIGURE 13. TEFLON/FOIL LAMINATE BLADDER AFTER HORIZONTAL EXPULSION - TOP VIEW

As in the case of the vertical tests, expulsion efficiencies in the horizontal attitude exceeded 99% at a tank assembly ΔP of 6 psi as shown in Table 1 and Figure 12. The first horizontal expulsion (No. 5) was not instrumented sufficiently to obtain an efficiency curve. Figures 13 and 14 are top and end views of the plexiglass tank after completion of the first horizontal expulsion.

Re-expansion of the bladder in the horizontal position after the first expulsion resulted in a 15° twist of the bladder. The same twist was experienced after each of the remaining three horizontal expulsions. In each case, the twist was removed by turning the tank to the vertical position, partially collapsing the bladder and re-expanding in the vertical position.

After each re-expansion, the bladder was visually checked through the plexiglass shell and no visible damage or residual hard creases were noted. Helium leakage tests of the bladder were performed prior to the first and fifth expulsion and following the eighth expulsion. With a ΔP of 10 psi across the bladder for a period of 1 hour, zero leakage was recorded in each case.

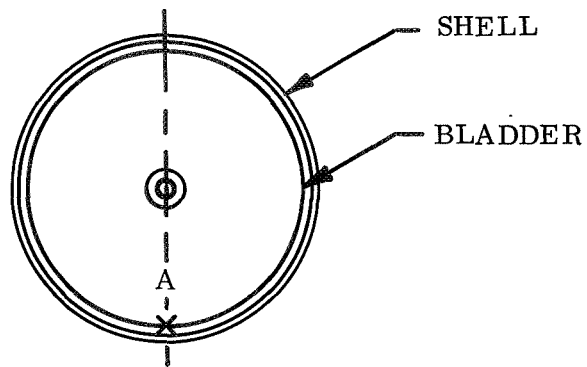
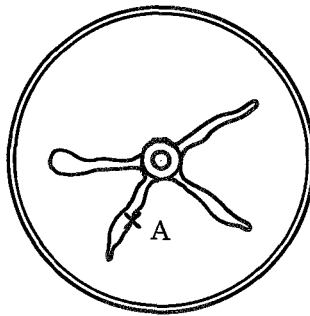
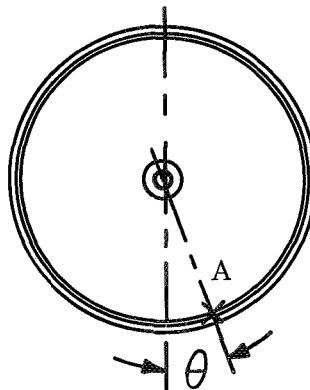
FIGURE 16. SKETCH SHOWING TYPICAL HORIZONTAL
FOLDING PATTERN AND TWIST

Several design approaches were studied and evaluated. These included variation of the diffuser cone flow pattern and ΔP by varying the number, size, and pattern of the holes in order to control the orientation of the bladder extremities. The objective of these modifications (as listed in Table 2) was to minimize bladder twist at the end of an expulsion and, if possible, prevent the bottom of the bladder from lifting at the end of an expulsion. If this could be accomplished, position A on the bladder as shown in Figure 16 would not change and the twist angle would remain zero.

POSITION OF POINT A
PRIOR TO EXPULSION

POSITION OF POINT A
AFTER EXPULSION AND EVACUATION

POSITION OF POINT A
AFTER FILL

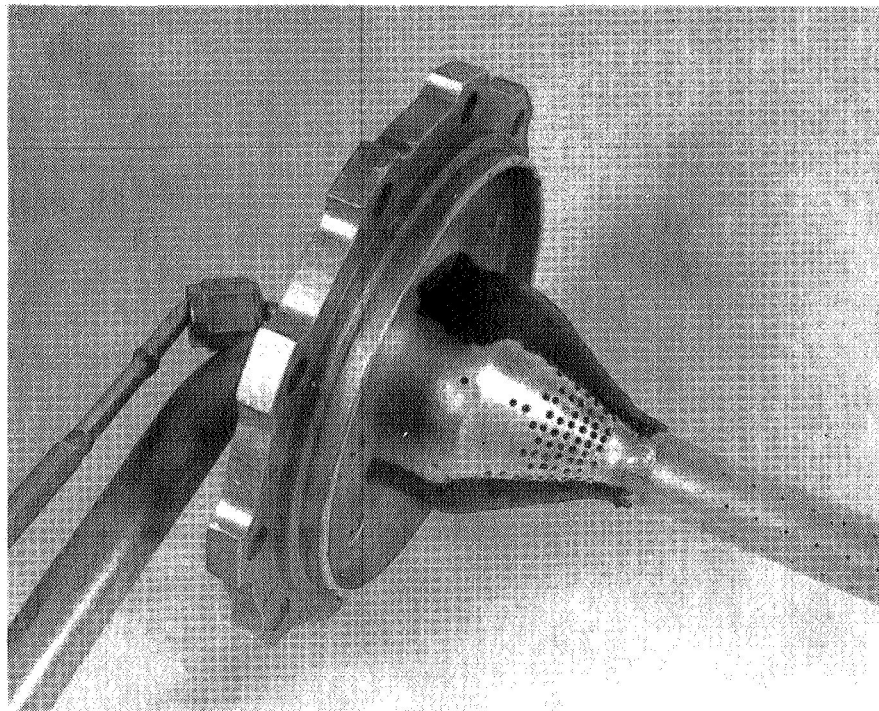
FIGURE 19. DIFFUSER ASSEMBLY: FLANGE END CONE -
SHOWS TYPICAL SEALING OF HOLES TO
CHANGE FLOW PATTERN

Test Series No. 2 consisted of 10 expulsions with the holes in the tubular portion of the diffuser taped shut and flowing through the end cones only. Bladder twist after liquid loading varied from 0.5 inch counter-clockwise to 1.5 inches clockwise, with individual measurements of 1.5 cw, 0.7 cw, 0.5ccw, 0.5ccw, 0.7 cw, 0.9 cw, 0.8 cw, 0.7 cw, 0.5 cw, 0.4 cw.

This test series indicated a distinct improvement in bladder twist over Test Series No. 1, with the degree and range of twist approximately half the values in Series No. 1.
